**InspectionTechnologies Company**  
**17 Wright Lane, South Hero Vermont 05486**  
**(866) 816-6907**

Inspection No: 201005-1234      Inspector: Michael Schirmer

Inspection Date: 5/5/2010

Dwelling: 2404 Sesame Street  
Stratus Vermont

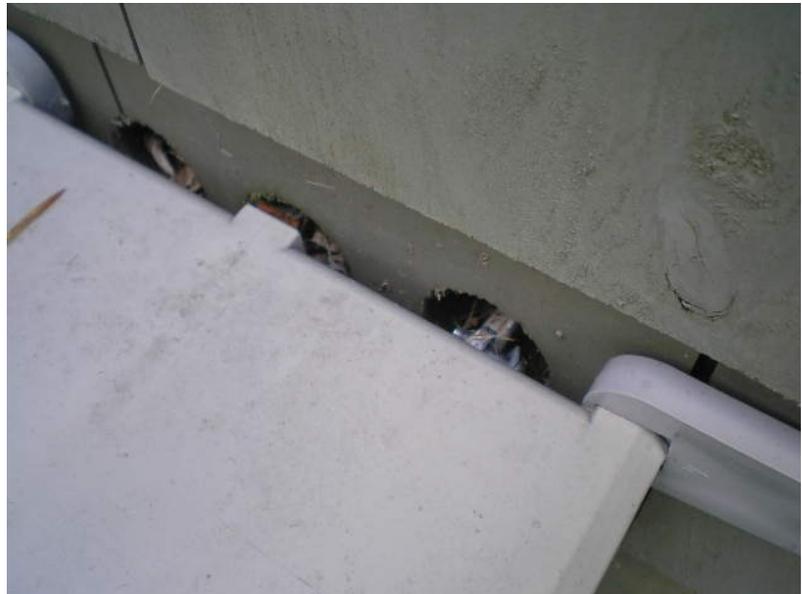
Suggest caulking all penetrations through siding such as pipes, wires and vents as needed to avoid water intrusion and pests.

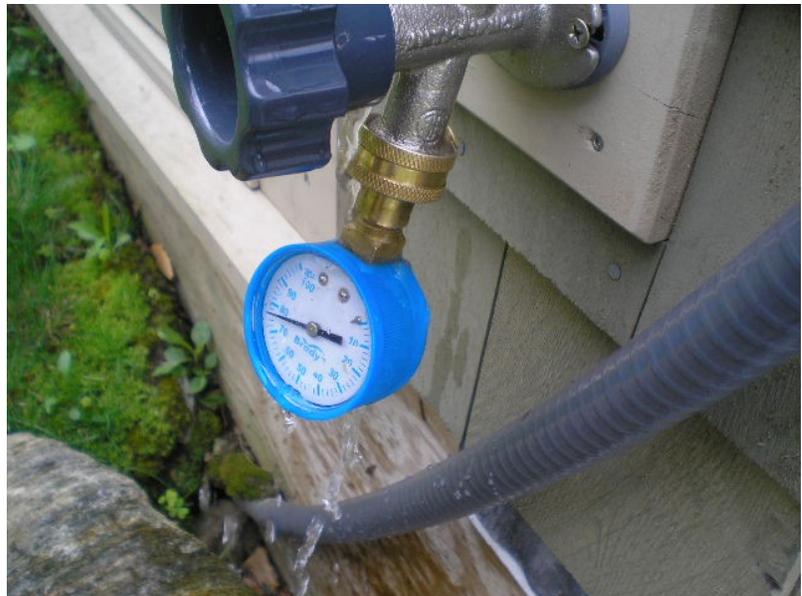
Left side hose bibb leaks when under pressure. Possible deteriorated seals. Suggest replacement as needed to avoid leaks and water waste. Consult a qualified plumber.

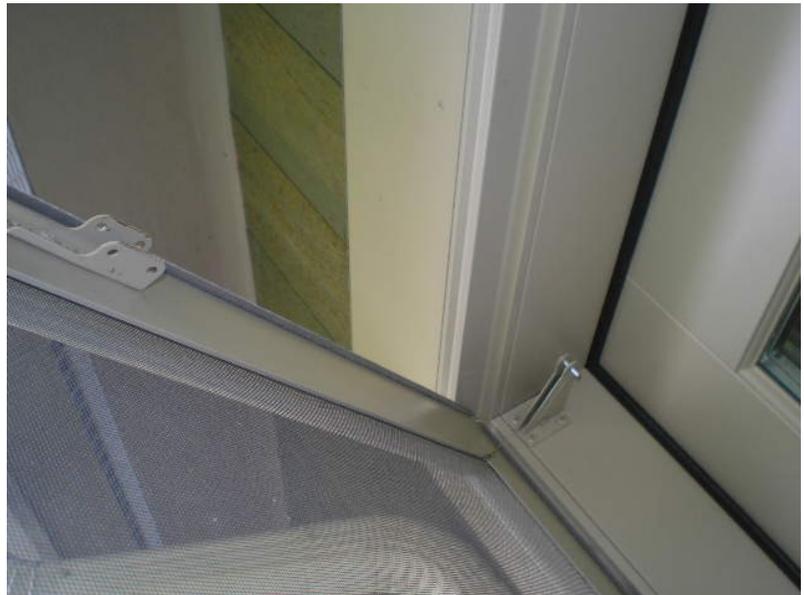
Missing damper/self-closer noted at the rear screen door.  
Suggest installing a proper damper/self-closer to avoid door damage.

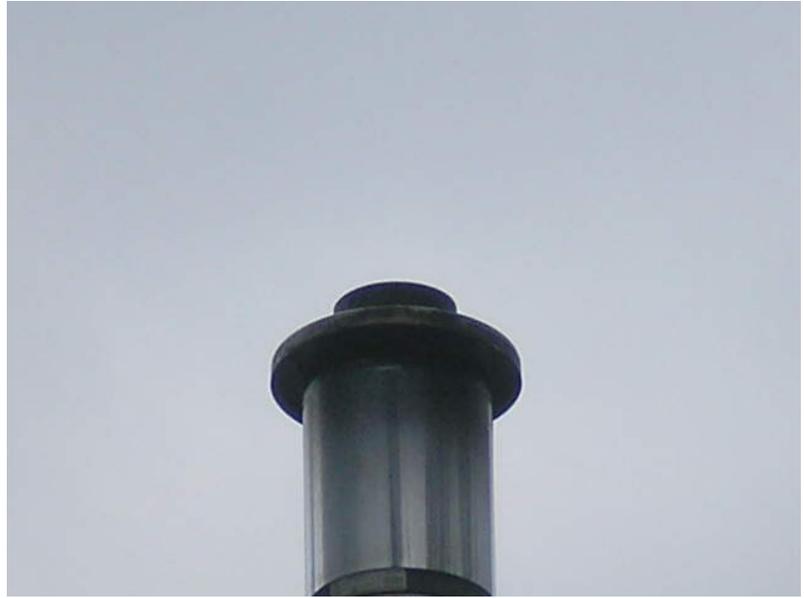
Replace missing spark arrester at the rear chimney for safety.  
Appears to have blown off - unable to locate.

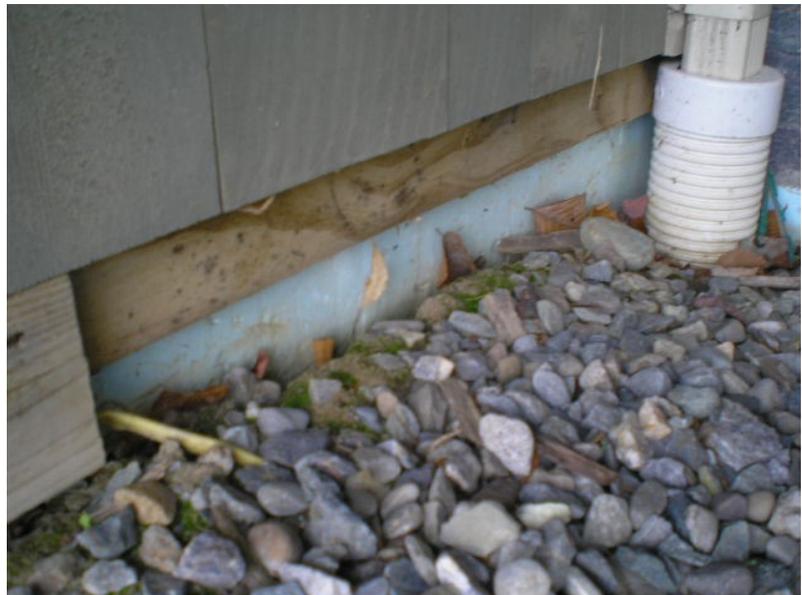
Non-compliant: Rigid Styrofoam insulation noted on exterior of foundation. This is generally not an accepted practice due to its ability to allow wood destroying insects to travel behind and through the insulation into the framing structures of the home. It is standard practice to require a minimum of 6 inches of bare concrete between ground surface and the sill plate (first course of siding) to avoid insects and moisture damage to the foundation. Suggest buyer consider removing this insulation as a future enhancement to the property or regularly monitor areas of band joists and sill.

In areas where the probability of insect infestation, extruded and expanded polystyrene, polyisocyanurate and other foam plastics shall not be installed on the exterior face or under interior or exterior foundation walls or slab foundations located below grade. The clearance between foam plastics installed above grade and exposed earth shall be at least 6 inches (152 mm).

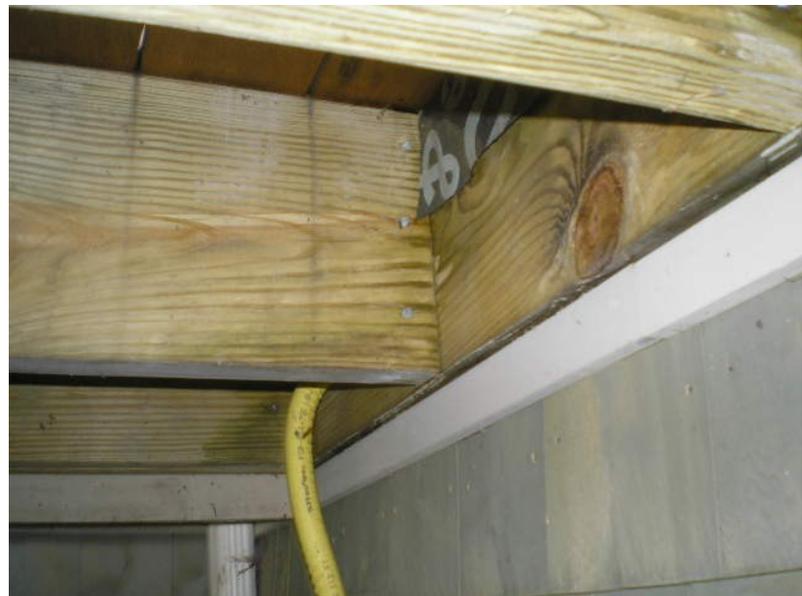
Joists are toe nailed into the ledger and outer band joist only at the front deck jut-out and at the rear entry landing. Recommend adding joist hangers to avoid failure potential. Consult a qualified contractor as needed.

Joists framing into the side of a wood girder shall be supported by approved framing anchors or on ledger strips not less than nominal 2 inches by 2 inches (51 mm by 51 mm).

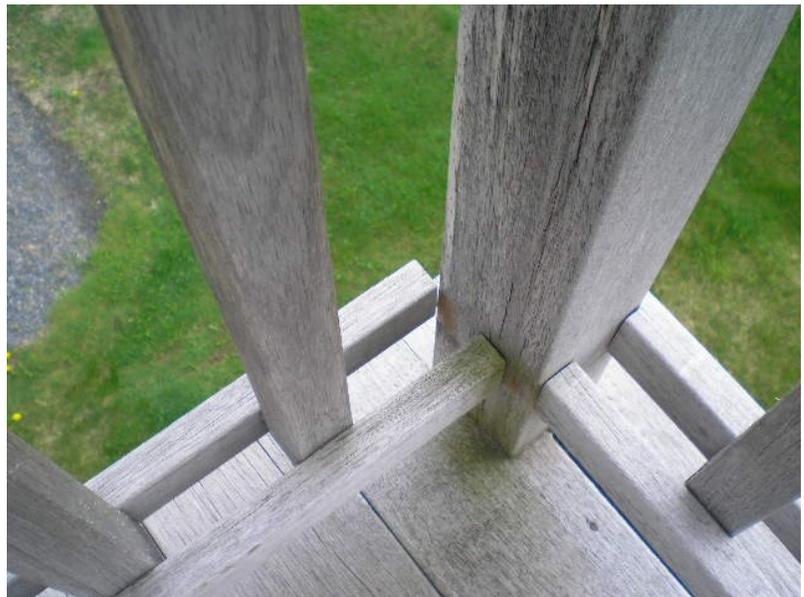
All sections of deck guard railings are loose and/or entirely detached at the bottom rails. Recommend further review by a qualified contractor for properly securing for safety.

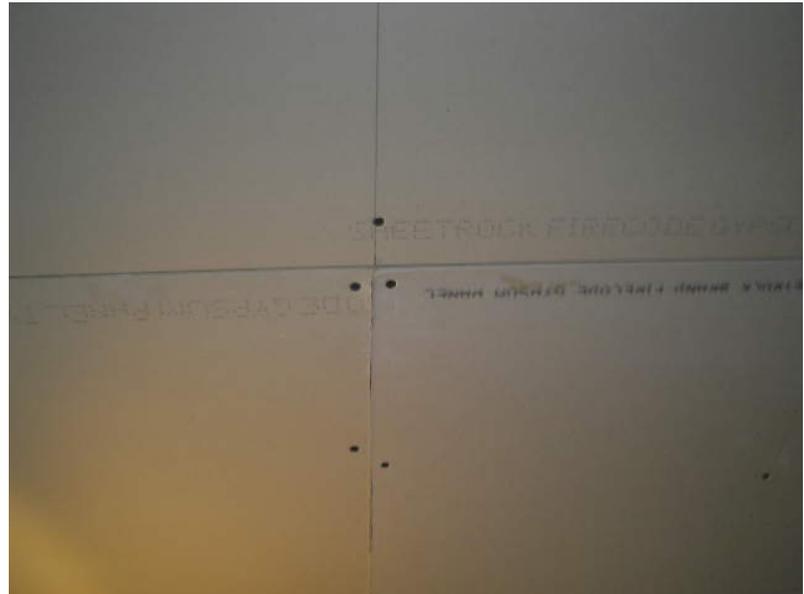
- 0510 Windows/Screens Serviceable.
- 0511 Fire Door  
COMMENTARY.  
Fire Door and weather stripping rated for fire/fume safety with an installed self-closer may not have been considered when home was built. Recommend client not store volatile and combustible materials in the garage area or operate engines in the garage area for safety.  
309.1 Opening protection.  
Openings from a private garage directly into a room used for sleeping purposes shall not be permitted. Other openings between the garage and residence shall be equipped with solid wood doors not less than 1 3/8 inches (35 mm) in thickness, solid or honeycomb core steel doors not less than 1 3/8 inches (35 mm) thick, or 20-minute fire-rated doors.
- 0512 Service Door Not Present.
- 0513 Fire Wall/Ceiling  
COMMENTARY.  
Fire Ceiling is compromised due to sheetrock joints and nails must be taped and finished.

No Fire Wall. Fire rated walls and ceilings rated for fire/fume safety on common walls adjacent to main living areas may not have been considered when home was built. Recommend client not store volatile and combustible materials in the garage area or operate engines in the garage area for safety.

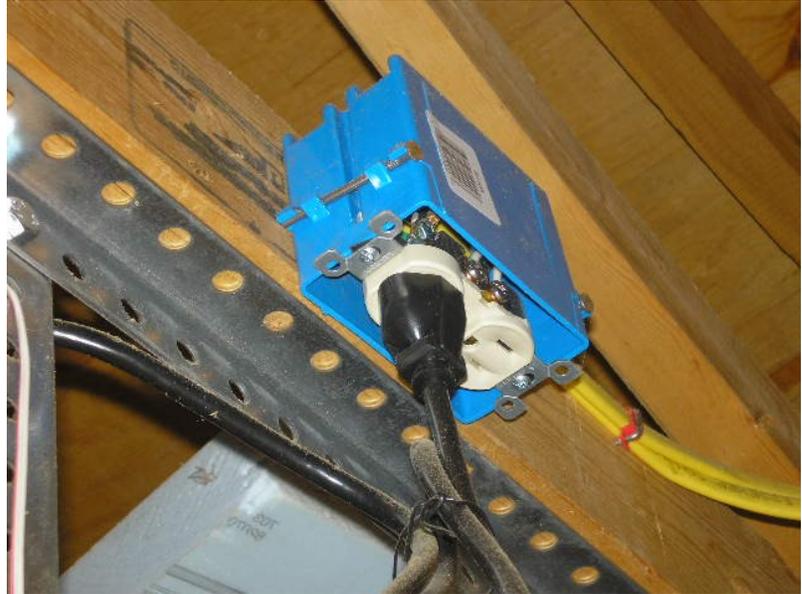
Missing outlet covers noted at the garage door opener receptacle outlets. Suggest installing required covers to avoid shock hazard.

Outlet boxes shall be effectively closed with a cover, faceplate or fixture canopy.

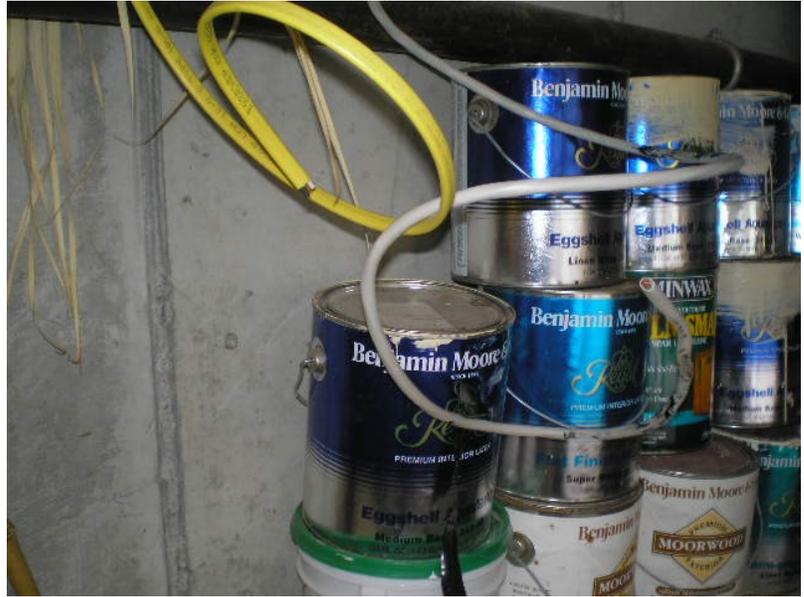
Exposed/loose/hanging wires noted at the rear wall of the garage. This is a safety concern if used where it could be subject to physical damage or accidental human contact. Wires were not 'live' at the time of inspection, although inspector cannot determine if wires could be made live by an unidentified circuit breaker or switch. Client should consult with a qualified electrician for removal or proper termination as needed to avoid shock hazard.

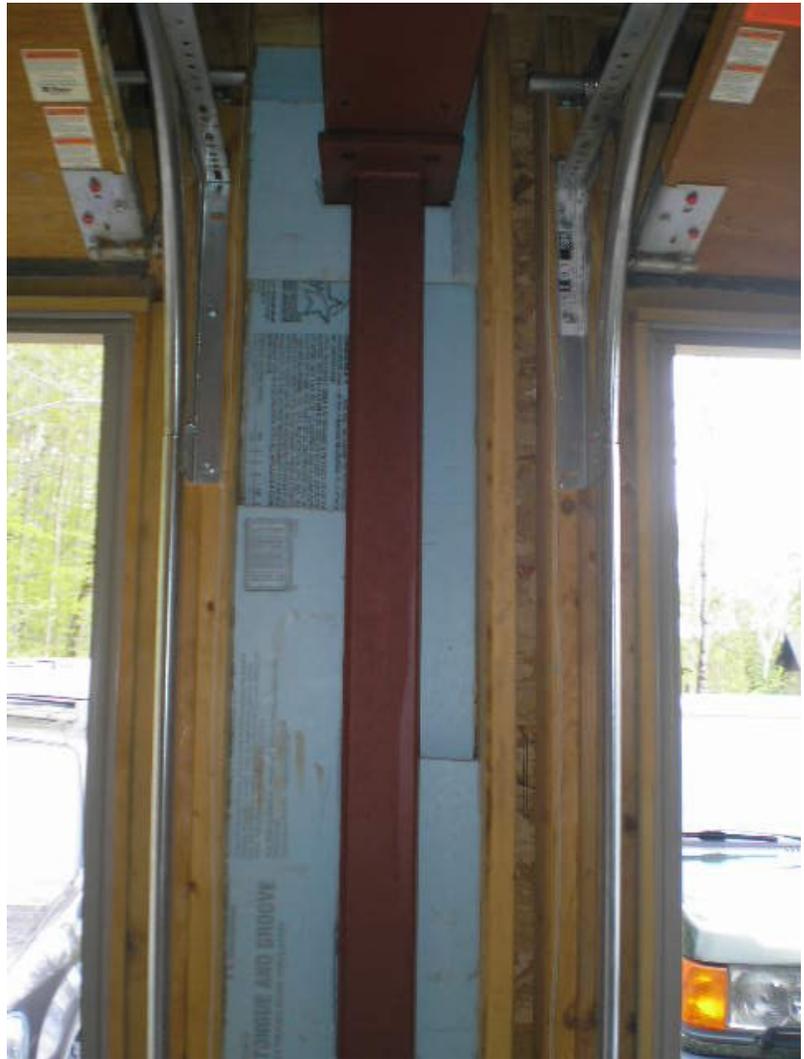
Foam plastic, except where otherwise noted, shall be separated from the interior of a building by minimum 1/2-inch (12.7 mm) gypsum board or an approved finish material equivalent to a thermal barrier to limit the average temperature rise of the unexposed surface to no more than 250°F(121°C) after 15 minutes of fire exposure to the ASTM E 119 standard time temperature curve.

Note: There is a large pile of foam plastic insulation stacked in the rafters. Suggest removal due to fire safety concerns.

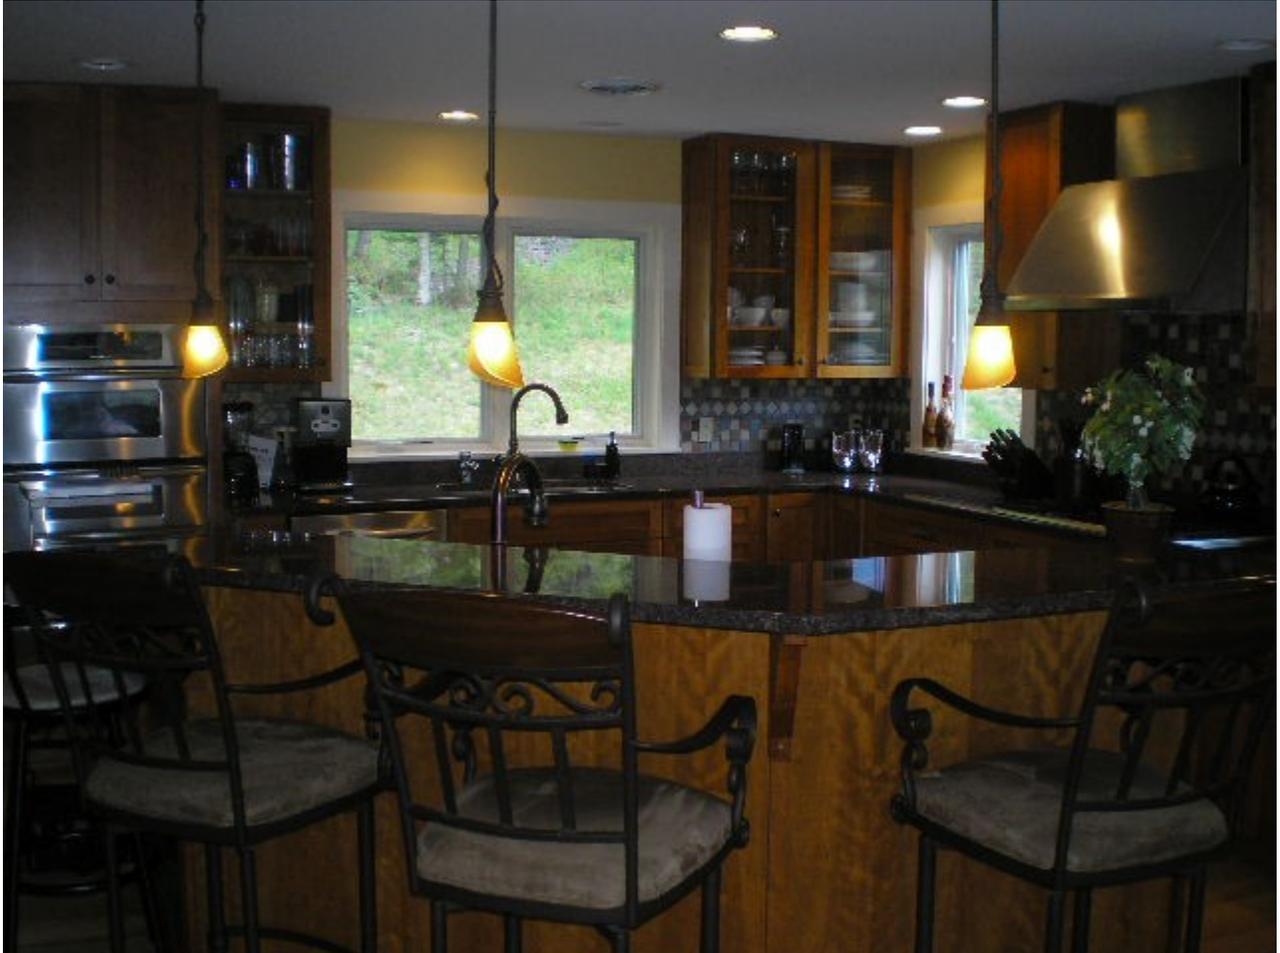
Step #	Component	Comments
1301	Floor	<p>MAINTENANCE. Wood.</p> <p>Flooring is buckled from in front of the dishwasher to the refrigerator. Flooring is loose in front of the refrigerator. This condition is generally a sign of a previous kitchen flood. One or more flooring boards may need to be replaced. Check subflooring for water damage. Consult a qualified flooring contractor as needed.</p>

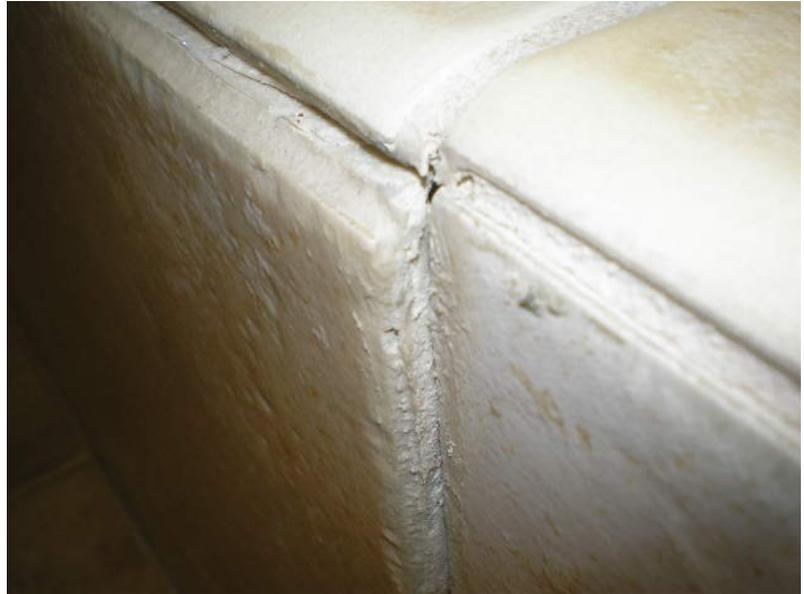
Loose tiles observed at the tub decking. Grout gaps observed. Suggest further review by a qualified tile contractor for repairs as needed to avoid water intrusion to the substrate.

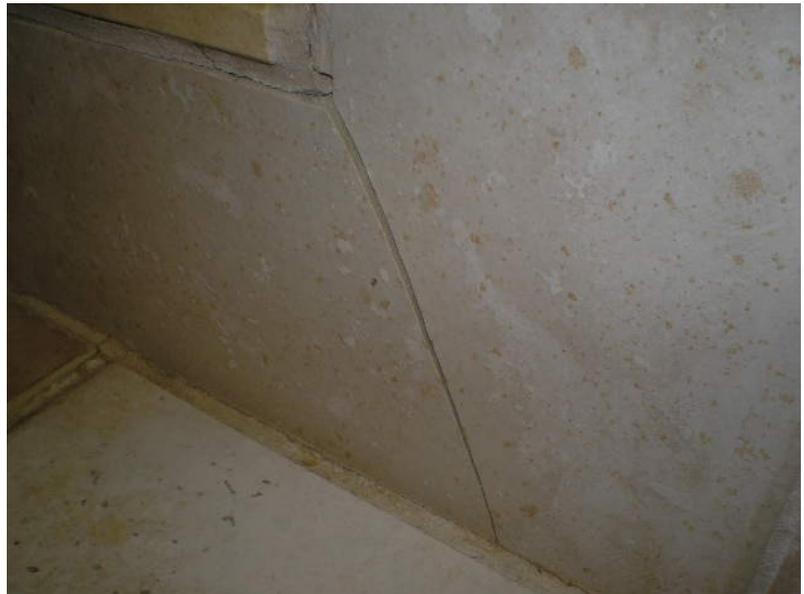
Cracked tile observed at the stall threshold. Recommend sealing or replacing to avoid water intrusion to the substrate.

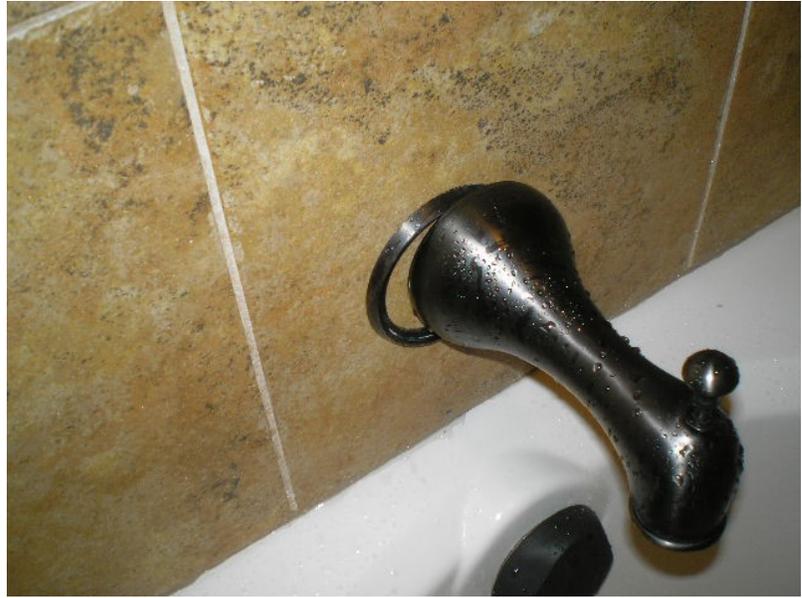
Step #	Component	Comments
1901.3	Location	Serviceable. Basement.
1902.3	Floor	Serviceable. Tile.
1903.3	Walls	Serviceable. Paint.
1904.3	Ceiling	Serviceable. Paint.
1905.3	Doors	Serviceable.
1906.3	Windows/Screens	Serviceable.
1907.3	Electrical	<p>MAINTENANCE. Ground fault interrupter provided for safety.</p> <p>Tub/Shower light fixture inoperable at time of inspection. Possible burnt bulb. Suggest client verify proper operation prior to closing.</p>
1908.3	Exhaust Fan	Serviceable.
1909.3	Heat Source	Serviceable. Radiant floor heat.
1910.3	Tub/Surround	Serviceable.
1911.3	Tub Enclosure	Serviceable.
1912.3	Tub Faucet	<p>MAINTENANCE. Spout escussion is loose. Suggest repairs as needed to avoid water intrusion into the plumbing wall.</p>

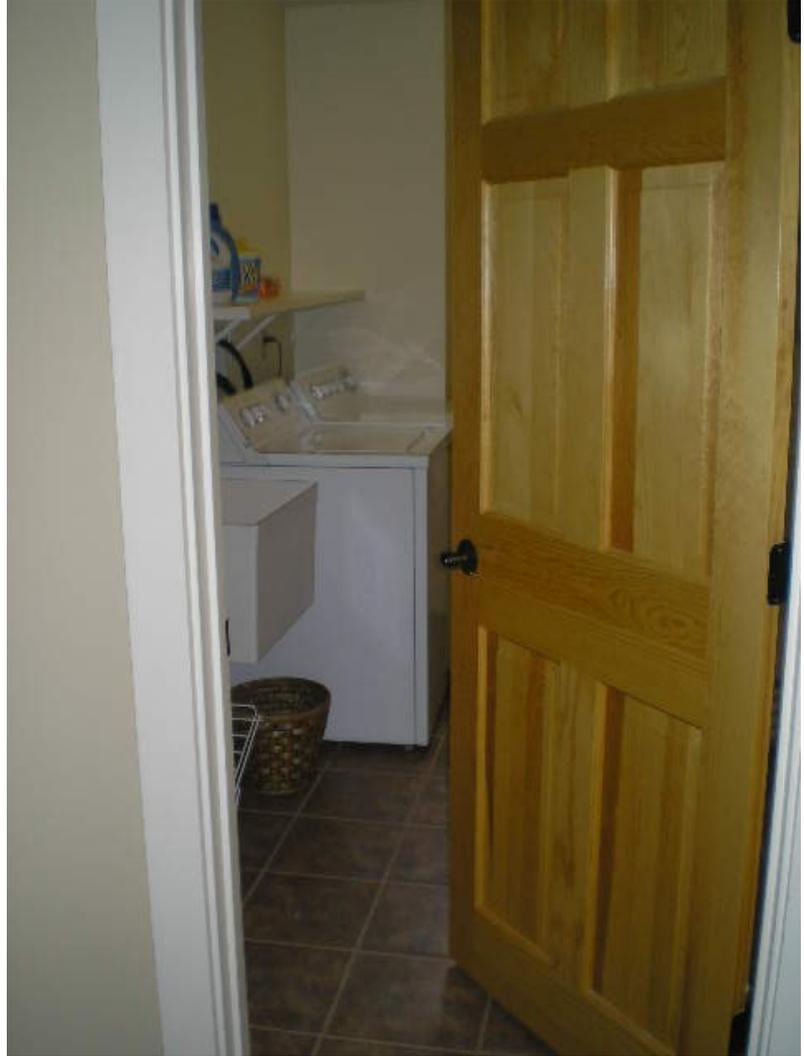
When a fuel burning appliance is operated in a tight space, it is standard practice that the space have a louvered door or air vents be placed in the wall for adequate combustion air/draft balancing air. Dryer requires approximately 250 sq.ft. of combustion air/draft balancing air to operate properly and safely. Recommend further review by a qualified gas service technician for adding proper make-up air as required to ensure safety. We suggest changing the solid door to a louvered door. See 'Heating/AC' section of this report for additional information.

The required volume of indoor air shall be determined in accordance with Section G2407.5.1 or G2407.5.2, except that where the air infiltration rate is known to be less than 0.40 air changes per hour (ACH), Section G2407.5.2 shall be used. The total required volume shall be the sum of the required volume calculated for all appliances located within the space. Rooms communicating directly with the space in which the appliances are installed through openings not furnished with doors, and through combustion air openings sized and located in accordance with Section G2407.5.3, are considered to be part of the required volume.

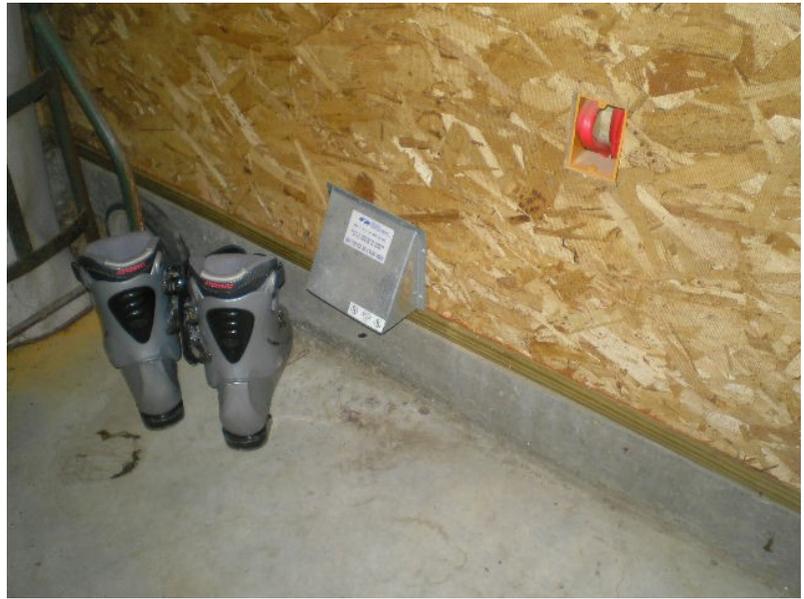
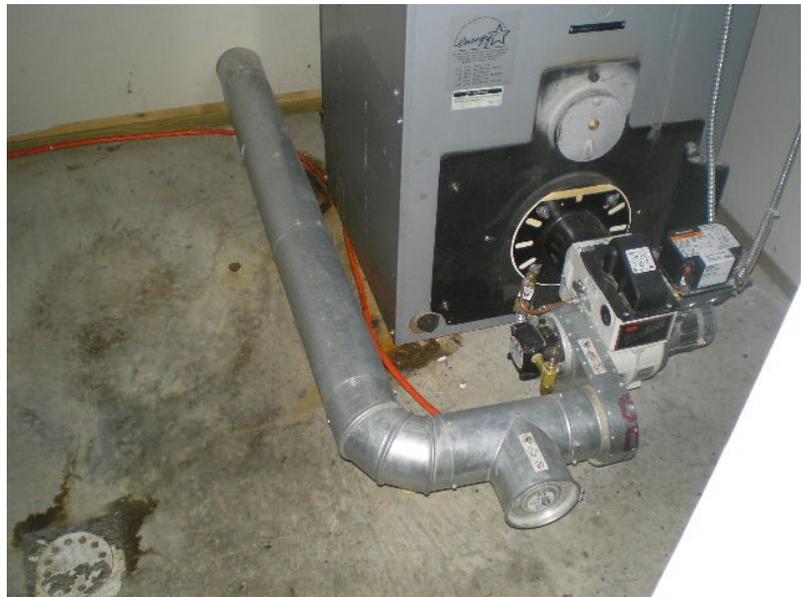
A very important code exists that when an ignition source is in a garage, or is located in a room that communicates with the garage through openings, the ignition source must be raised a minimum of 18" above the floor due to explosion hazard of gasoline vapors from vehicles. i.e.:

The inspector believes that obtaining air for combustion through a draft hood located in the garage is not only unsafe, but through ducting might even draw potential gasoline vapors directly into the combustion chamber of the boiler. This is an explosion hazard requiring immediate review by a qualified heating contractor for removing the garage source for combustion air or to approve/certify current installation. We suggest changing the utility room solid door and the laundry room solid door to louvered doors. See steps 0908 below and 0613 (Laundry) for additional information.

Combustion air shall not be obtained from an area in which flammable vapors present a hazard.

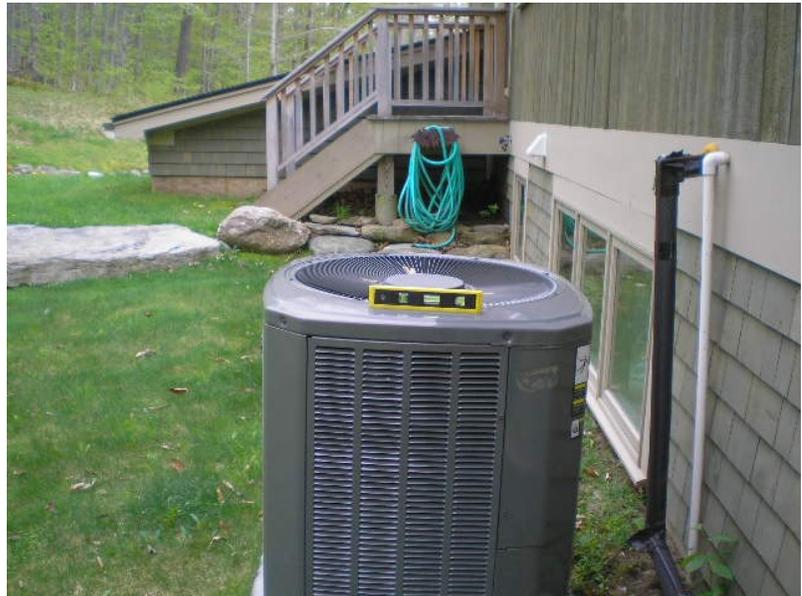
Condenser is located at the exterior rear of the building. The base of the condenser unit is not level. This could affect proper operation and efficiency of this unit. Suggest further review by a qualified HVAC contractor for re-leveling as needed.

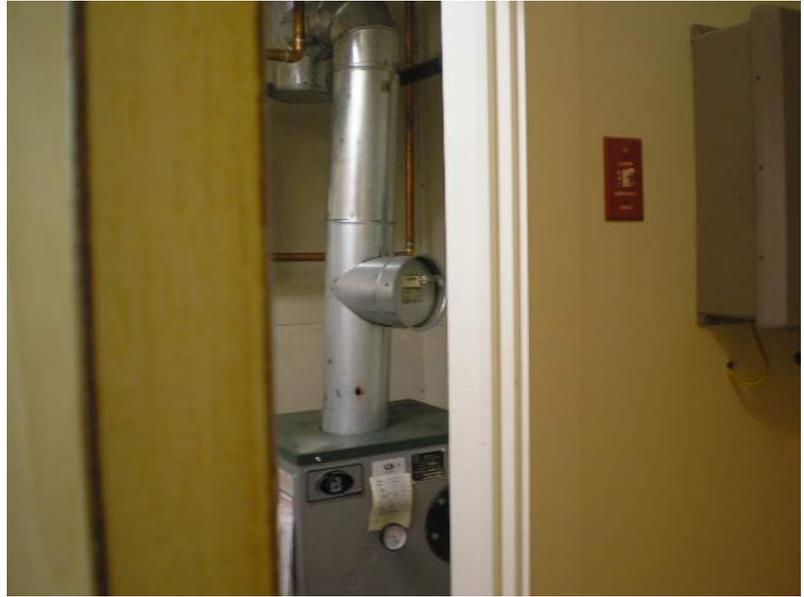
Draft balancing air for gravity venting of exhaust is obtained from within the small utility room only. When a fuel burning appliance is operated in a tight space, it is standard practice that the space have a louvered door or air vents be placed in a wall at both the ceiling level and the floor level for adequate draft balancing air. Boiler requires approximately 500 sq.ft. of draft balancing air (make-up air) to operate properly and safely. Recommend further review by a qualified heating contractor for providing proper make-up air or to approve/certify current installation. We suggest changing the utility room solid door and the laundry room solid door to louvered doors. See steps 0902 above and 0613 (Laundry) for additional information.

Liquid and solid fuel-burning appliances shall be provided with a supply of air for fuel combustion, draft hood dilution and ventilation of the space in which the appliance is installed, in accordance with Section M1702 or Section M1703. The methods of providing combustion air in this chapter do not apply to fireplaces, fireplace stoves and direct vent appliances.

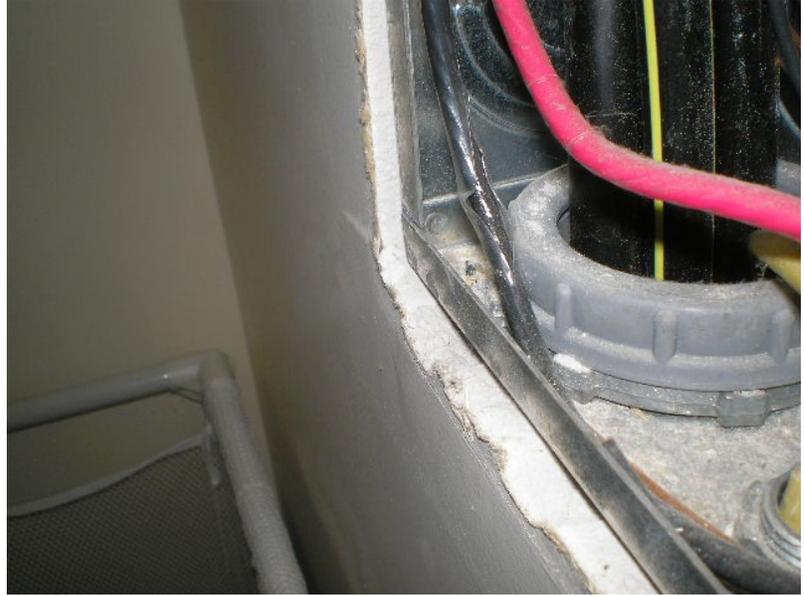
Replace one (1) missing panel cover screw.

Panel cover improperly installed over wall covering. Suggest further review by a qualified electrician to cut back wall surface to allow for proper installation of panel box cover. E3807.3 Position in wall.

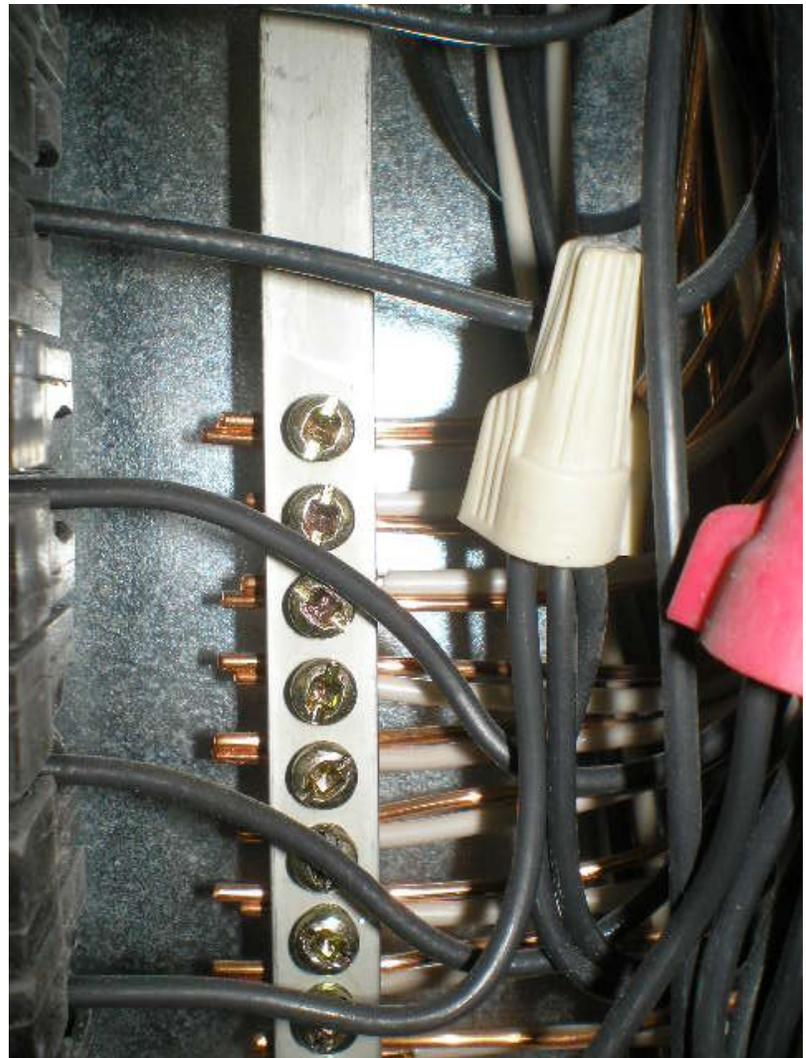
The connection of a neutral and equipment-grounding conductor in the same termination creates an issue and is not an ideal configuration and VOIDS THE UL RATING OF THIS PANEL. One of the objectives of the particular arrangement of bonding jumpers, neutrals and equipment grounds is to allow circuit isolation while keeping the equipment grounding conductor still connected to the grounding electrode (see UL 869A -Reference Standard for Service Equipment). When the neutral is disconnected, the objective is to still have the equipment ground solidly connected to the grounding electrode. If both the neutral and grounded conductor is under the same terminal, this cannot be accomplished.

If the screw were loosened by an electrician or became loose, one would lose both the return path for current as well as the fault clearing ability should a hot contact a metallic surface. An example of this condition occurring is in the following photograph. Note the scorching and burnt wires. Most would not want this potential in their home. Recommend further review by a qualified electrician for correction as needed or to approve/certify the current installation.

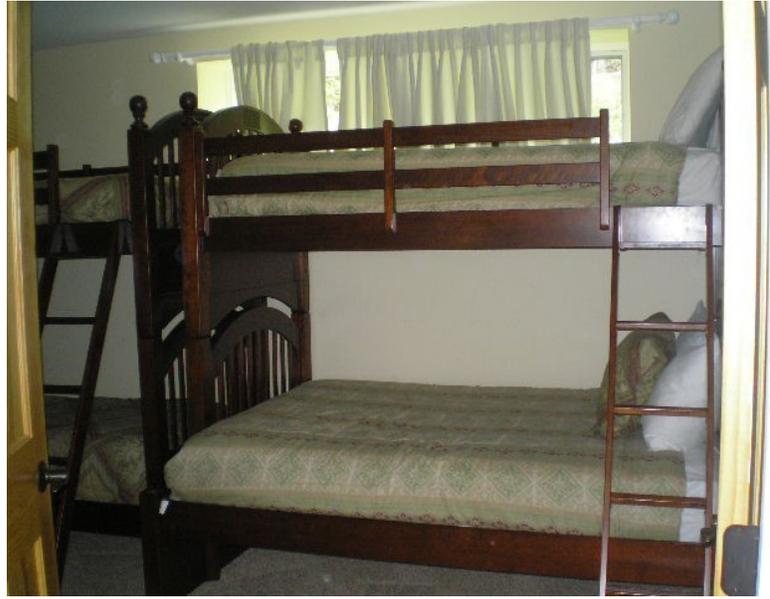
Unqualified windows noted in basement bedroom. Consult State Fire Marshall whether or not this will be a problem in obtaining Certificate of Occupancy.

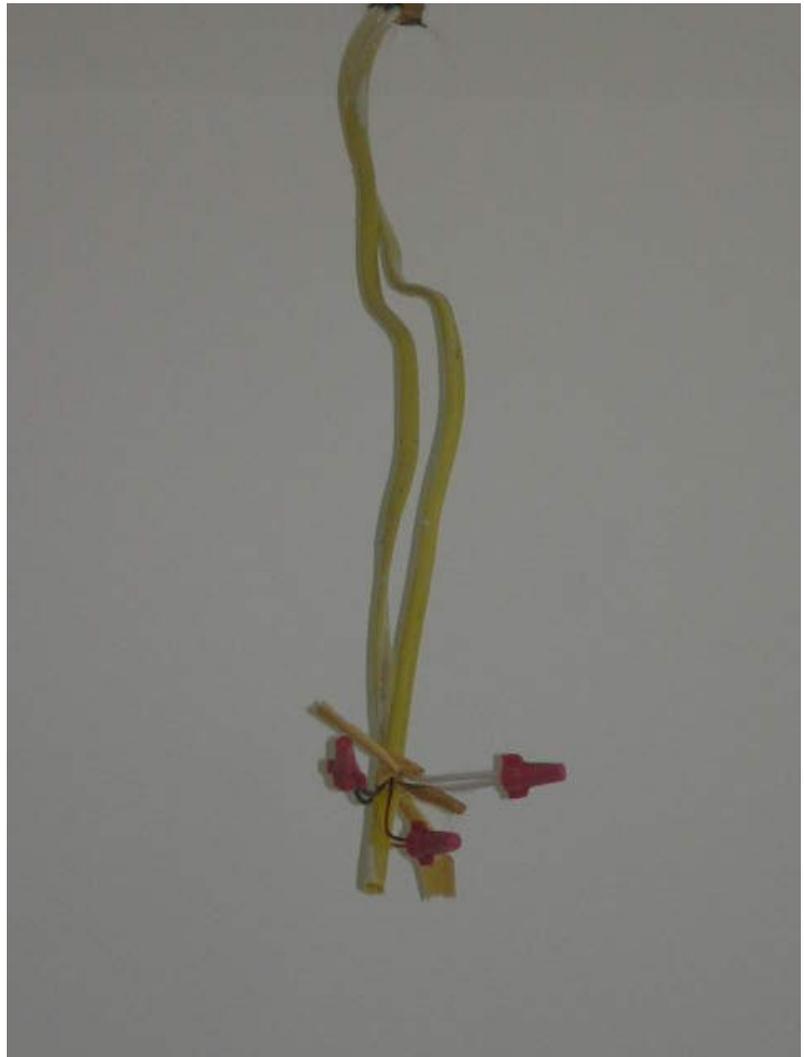
Exposed/loose/hanging wires noted at the living room cathedral ceiling. Client should consult with a qualified electrician for installation of intended lighting and/or ceiling fan or to properly terminate in a covered junction box for safety.

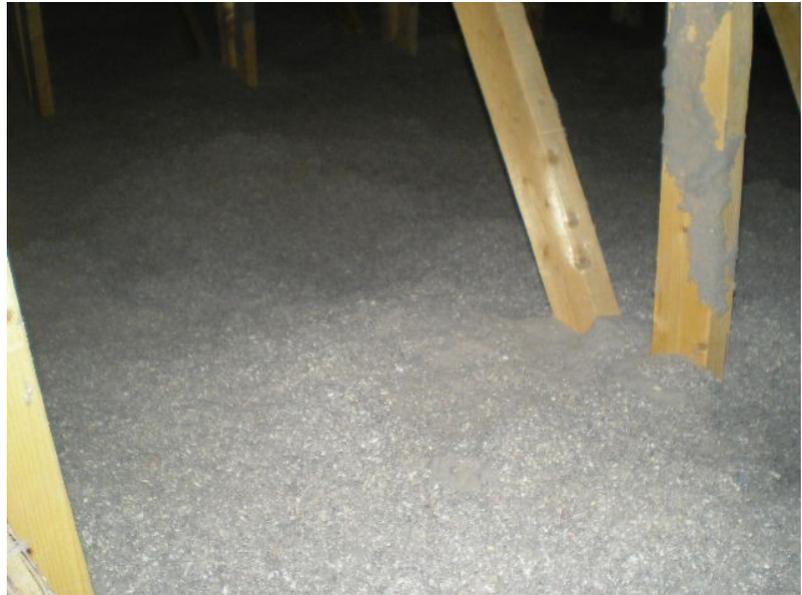
Gaps noted at several areas down the center (serviceman tracking). Suggest rearranging insulation to avoid gaps in the overall insulation value of the attic insulation.

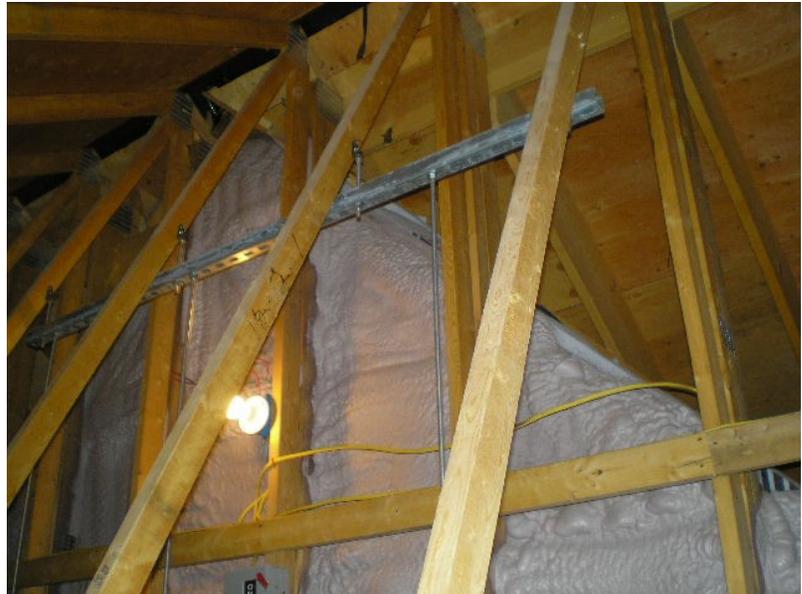
Within attics and crawlspaces where entry is made only for service of utilities, foam plastics shall be protected against ignition by 1 1/2-inch-thick (38 mm) mineral fiber insulation, 1/4-inch-thick (6.4 mm) wood structural panels, 3/8-inch (9.5 mm) particleboard, 1/4-inch (6.4 mm) hardboard, 3/8-inch (9.5 mm) gypsum board, or corrosion-resistant steel having a base metal thickness of 0.016 inch (0.406 mm).
