**InspectionTechnologies Company**  
**17 Wright Lane, South Hero Vermont 05486**  
**(866) 816-6907**

Inspection No: 201005-1234      Inspector: Michael Schirmer

Inspection Date: 5/5/2010

Dwelling: 2404 Sesame Street  
Stratus Vermont

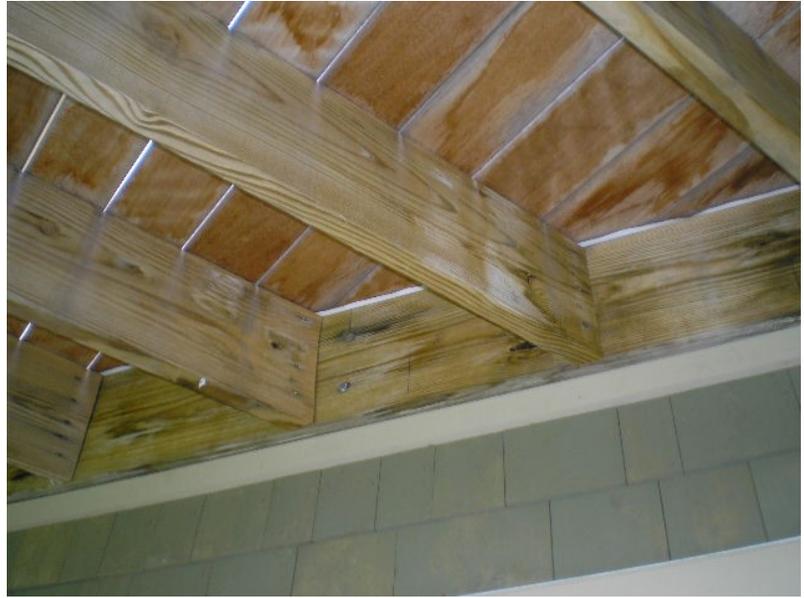
0206 Stairs/Stoops

Serviceable. Wood.

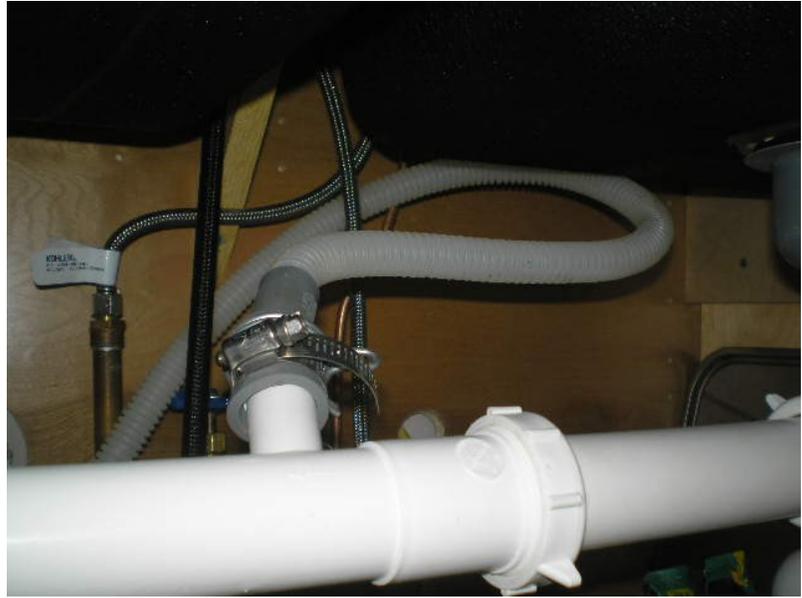
1314	Stove/Cook Top	Serviceable. Propane Gas.
1315	Oven	Serviceable. Electric.
1316	Hood/Fan/Light	Serviceable. Vents to exterior.
1317	Microwave	Serviceable. Built-in microwave ovens are tested using normal operating controls. Unit was tested for microwave leaks and appeared to be serviceable at time of inspection.
1318	Heat Source	Serviceable. Radiant floor heating.
1319	Kitchen Comments	Serviceable. ISE hot water dispenser noted and tested.

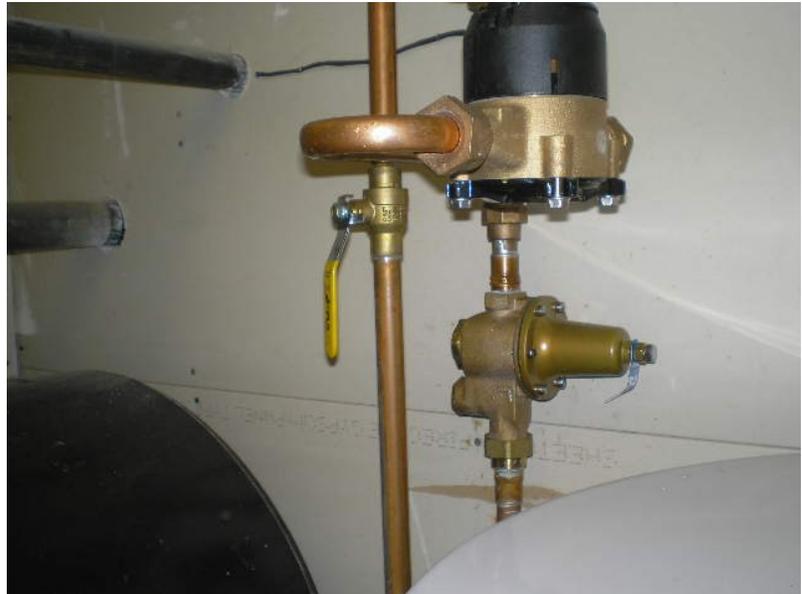
Step #	Component	Comments
1001	Plumbing Supply System	Serviceable. Water pressure at time of inspection was 72 psi. Pressure was within normal range of 40 to 80 psi. Property has public water supply. Shut off location is at water main in basement utility room.

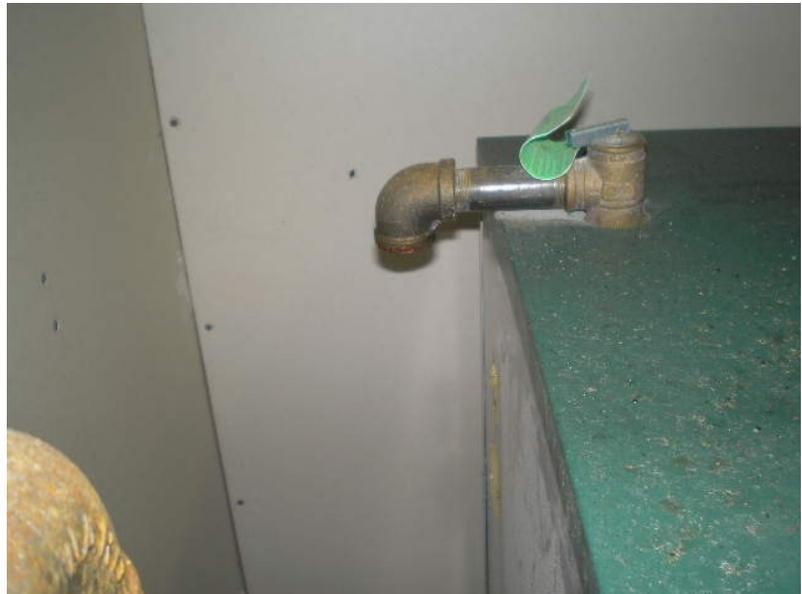
Step #	Component	Comments
0901	Heating	<p>Serviceable. Hot water; Oil. Electrical safety switch (Firomatic) noted. Electrical disconnect provided near this unit.</p> <p>Boiler is a Peerless cast iron model. Appears to be original equipment installation.</p>
0902	Conditions	<p><b>ACTION.</b></p> <p>Discharge pipe is missing on the temperature pressure relief valve. Suggest installing the required 3/4 inch metal discharge pipe on the temperature pressure relief valve to within 1-1/2 feet of the floor or to exterior of the building to ensure safety.</p> <p>M2002.4 Pressure-relief valve.</p> <p>Boilers shall be equipped with pressure-relief valves with minimum rated capacities for the equipment served. Pressure-relief valves shall be set at the maximum rating of the boiler. Discharge shall be piped to drains by gravity to within 18 inches (457 mm) of the floor or to an open receptor.</p>

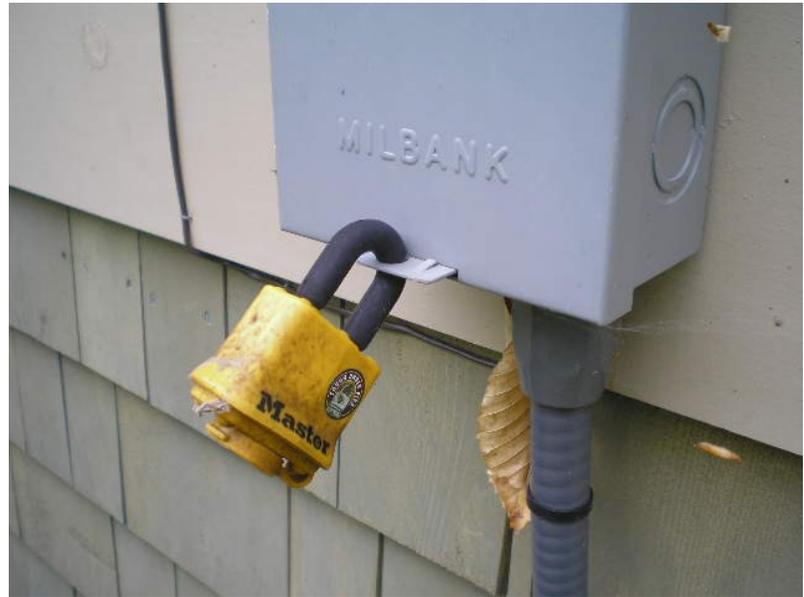
Outside temperature at time of inspection was below 60 degrees. To prevent damage to the air conditioning system, manufacturers warn against operating air conditioning units when the outside temperature is less than 60 degrees. This unit was not tested. Client is advised to verify proper operation of the unit with seller prior to closing.

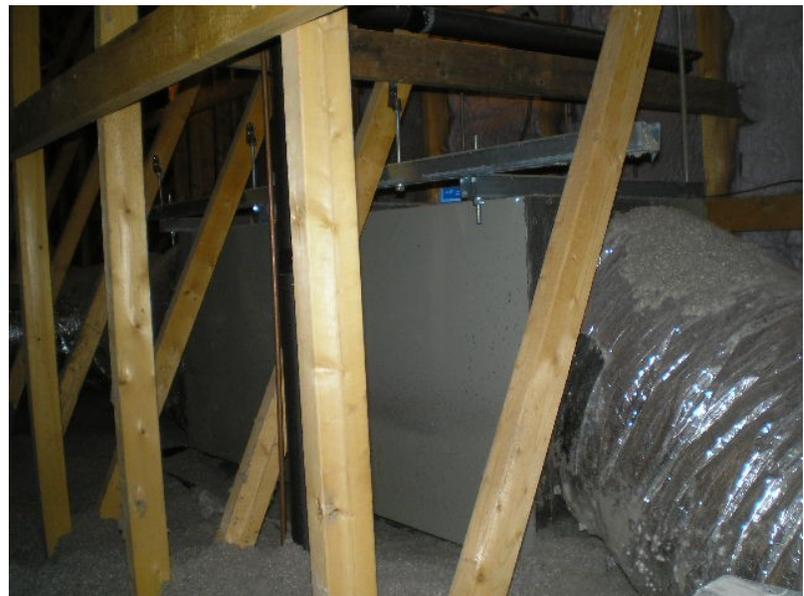
Fan center is located in the attic.

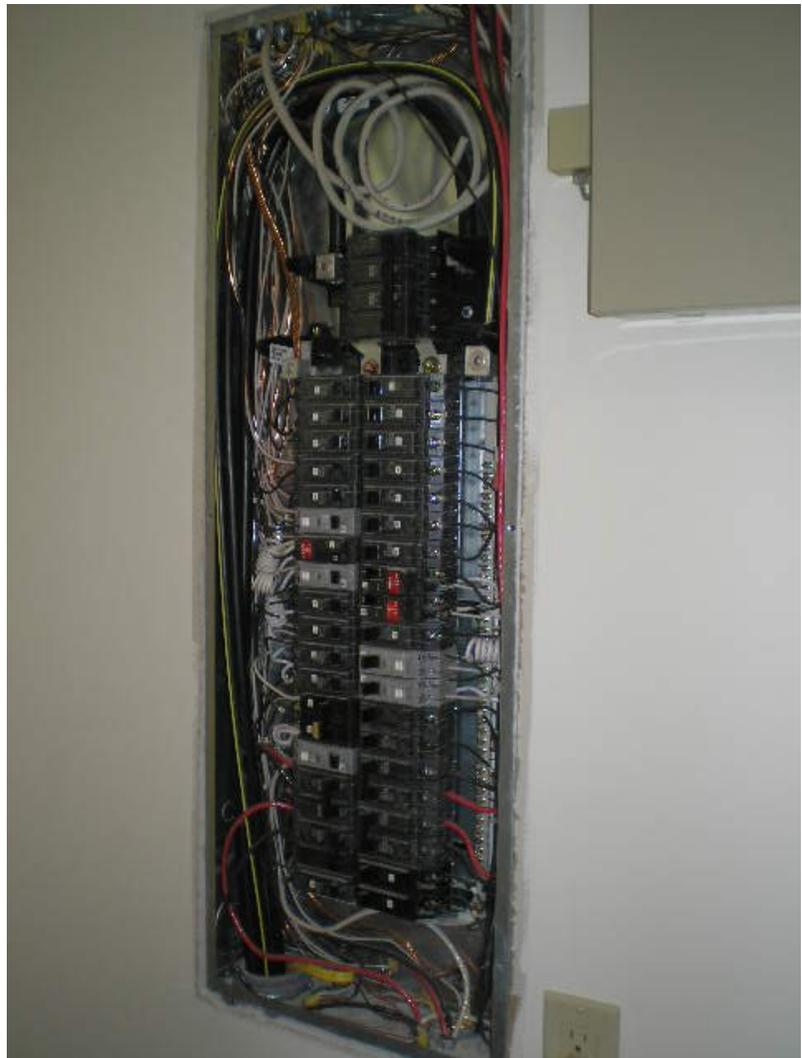
Step #	Component	Comments
1101	Electrical Main Box	<p>Serviceable. Amps. The main electrical service is approximately 200 amps. Branch circuit wiring is copper. Breakers present to provide overload protection. Main conductor is aluminum. Main disconnect noted. Service entrance is underground. System appears to be properly grounded. The main panel is located at the laundry/utility area.</p> <p>Voltage. The main electrical service is approximately 240 volts.</p>

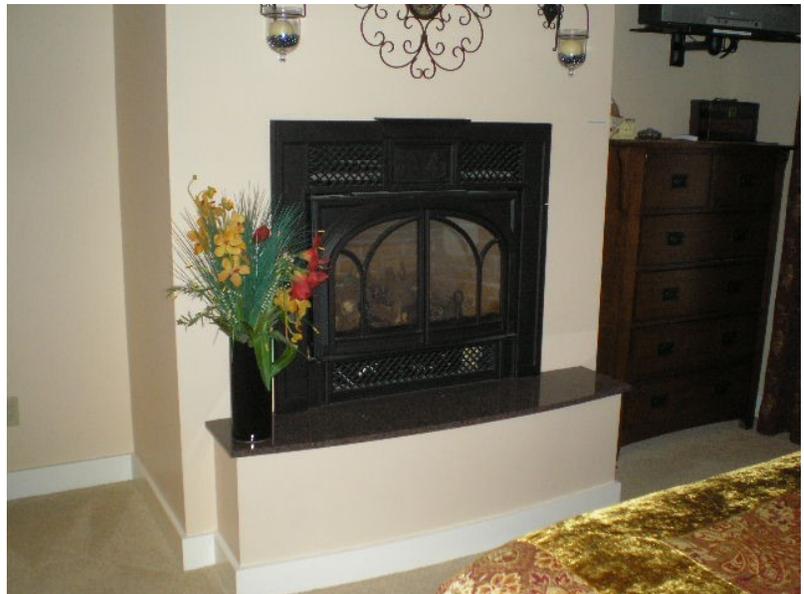
2nd level fireplace reviewed and tested. Gas logs; direct venting; operates from wall switch.

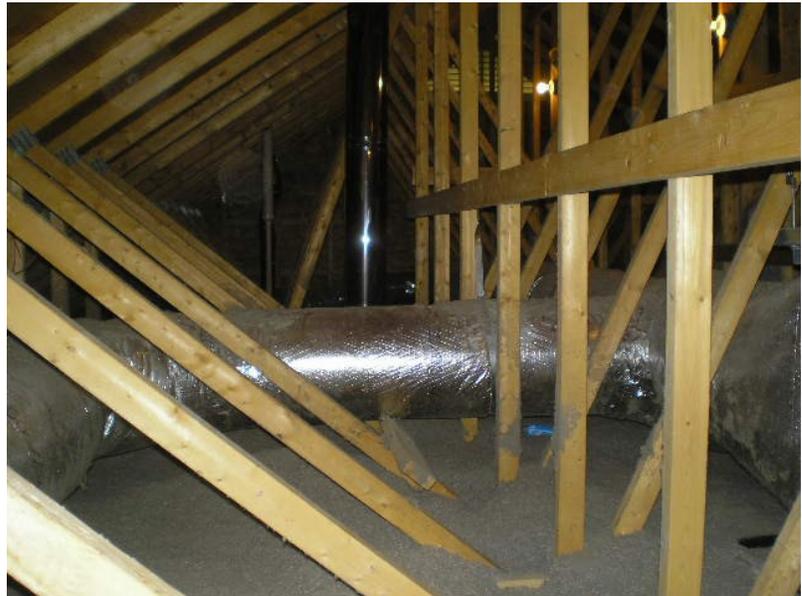
Step #	Component	Comments
0401	Access	COMMENTARY. Attic access located at the rear center bedroom ceiling scuttle hatch. Entering attics that are heavily insulated can cause damage to the insulation and attic framing. Attics with deep insulation cannot be safely entered due to limited visibility of the framing members upon which the inspector must walk. In such cases, the attic is only partially accessible, thereby limiting the review of the attic to the view of the hatch area only.
0402	Framing	Serviceable. Rafters. 2x4 rafters; 24" centers. Queen Post design.

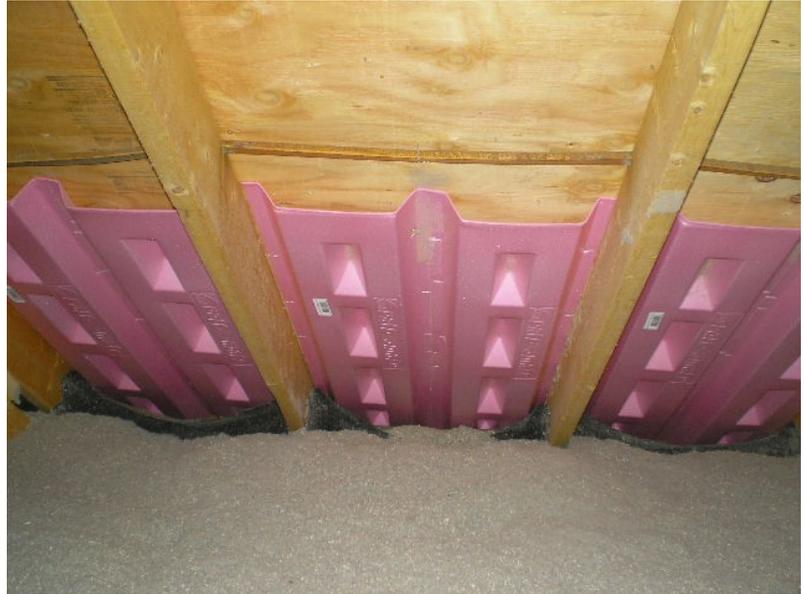
0403 Sheathing

Serviceable. Plywood.
